Testing Building Envelope Systems Using Infrared Thermography

Abstract

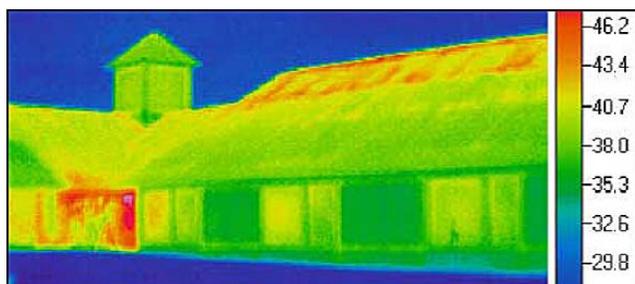
Image 1. Excessive heat loss and poor ventilation resulted in costly ice damage to this large roof.

Often the problems – as well as their causes and consequences – simply cannot be seen until after costly damage has been done. At that point the only recourse may be extensive, costly reconstruction. The commercial building in Image 1, a nursing home, had extensive problems resulting from a poorly designed roof/ceiling insulation system; these included excessive heat loss during the winter months and, as a result, extensive ice damage due to snow melt. Hundreds of thousand so dollars were spend in various, poorly planned attempts to correct the underlying causes. In the end the owners simply lived with the continued problem because corrective actions were deemed too expensive. Despite

this unfortunate resolution, the thermograms helped the owners negotiate a financial settlement with the architects and contractors.

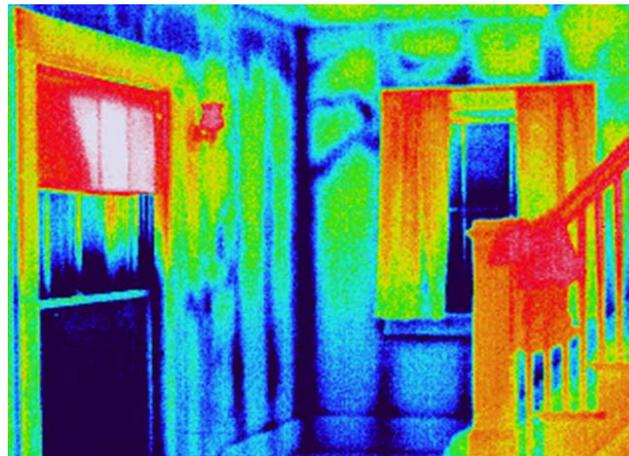
Image 2. When conditions are right, it is possible to locate missing or damaged insulation, such as this poorly installed injected foam in a residential building.

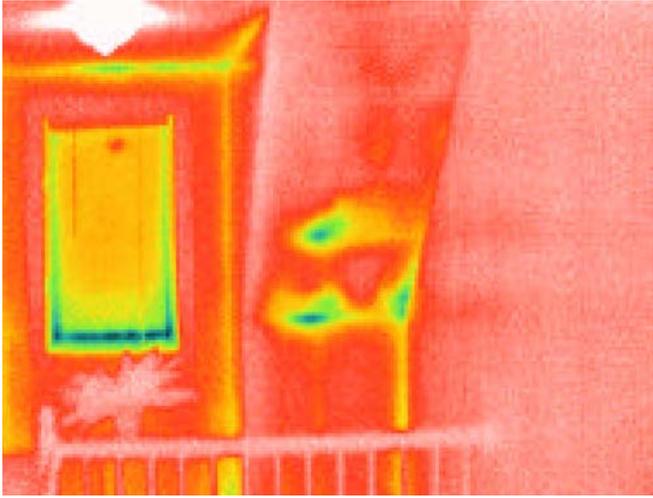
Image 3: The improperly installed fiberglass yields an irregular thermal pattern. The resulting cold spots commonly host wall stains or mold growth.

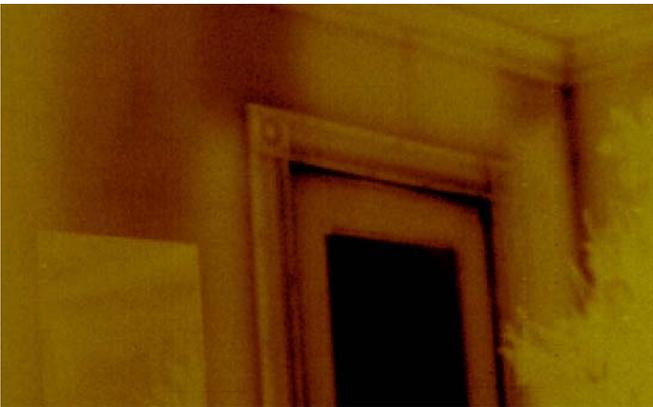
Image 4: Properly installed cellulose is an excellent insulation. Unfortunately, it is often poorly installed with missed areas and settling the most common quality problems.

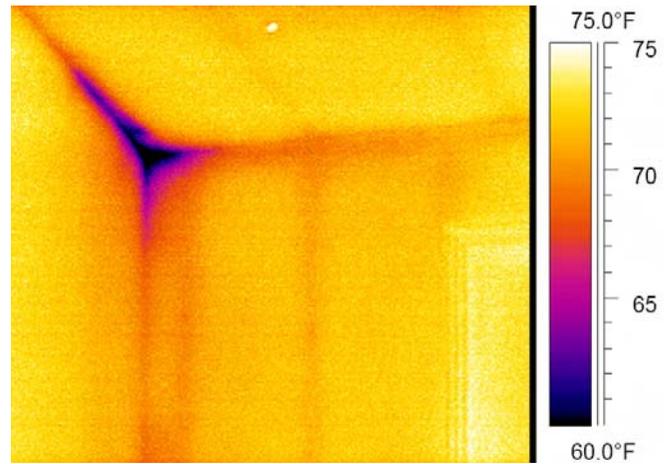
Image 5: Many types of insulation are susceptible to air infiltration. The fiberglass shown here does not stop air flow through the wall section.

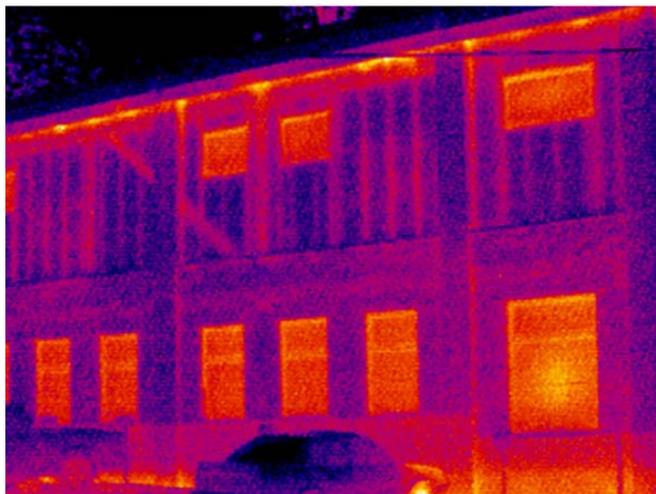
Image 6: All the framing and insulation is clearly visible in this commercial building. Normal pressure differences on the top floor result in air leaking past the envelope through various pathways.

under a pressure gradient. Image 6 shows the impact of warm air leaking out of this commercial building. This will typically go unnoticed until the fuel bill is paid.

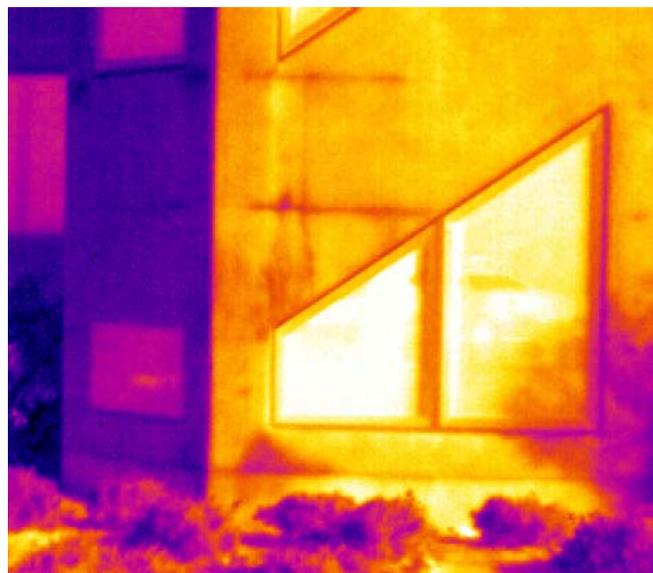
Image 7: EIFS construction is particularly susceptible to water intrusion resulting in both mold growth and wood rot problems.

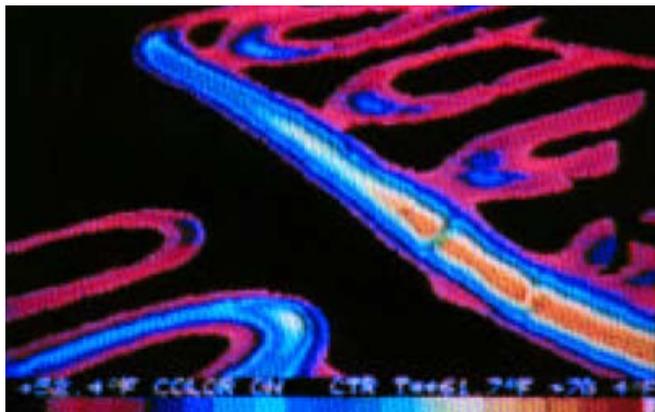
Image 8: Hydronic heating coils embedded in a concrete floor show up in this thermal image.

Heating coils are being used more and more either to keep outside walkways or entrance ramps snow free or to provide heat to areas and rooms via hot water or electric cables. Thermography provides a quick way to verify location and performance of these subsurface devices. Typically the thermal pattern shows up very clearly even when the heat source is embedded in several inches of concrete. Similarly, water pipes in wall sections can usually be located quite readily.

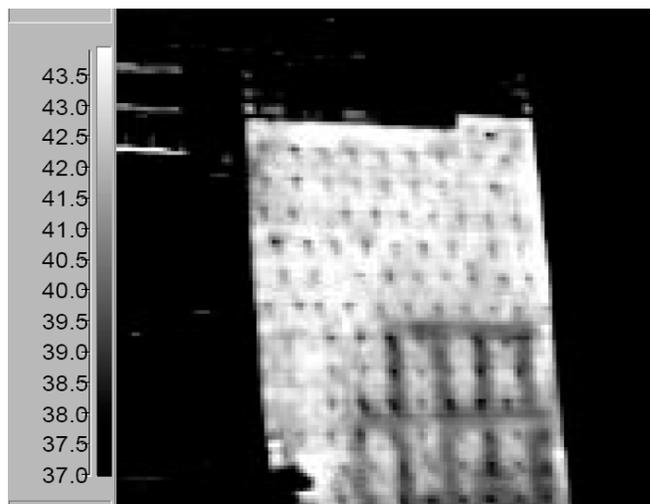
Image 9: This block wall is not uniformly grouted as was specified, leading to severe structural problems. Image courtesy Phil McMullen.

No area of application is more important these days, particularly in commercial buildings, than the verification of construction details and performance. Thermography is being used with great success to verify bond beams and placement of reinforcing in concrete masonry unit (CMU) walls as well as structural elements of pre-cast, tip-up walls. How? The solid portions of the wall change temperature more slowly than the rest. The inspection can be conducted anytime the wall is in a thermally transient condition – typically in the early evening as it cools down. Because the inspection is conducted during construction, deficiencies can be corrected prior to occupation with relatively minor inconvenience.

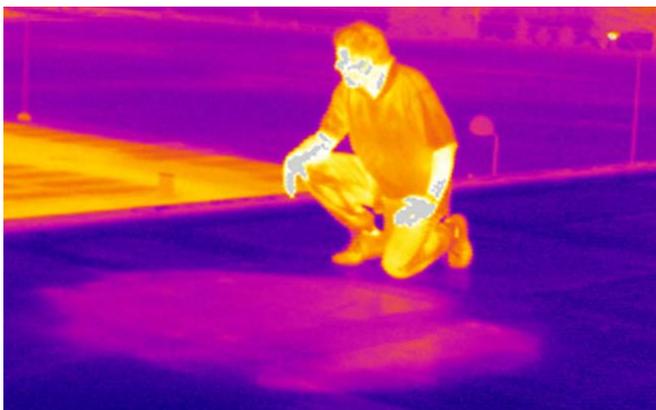
Image 10: The wet insulation in the roof system shows up clearly due to its greater thermal capacitance.

The inspection of flat roofs, especially built-up roofs (BUR) has been proven for a number of years. The technique allows for the detection of moisture trapped in a roof system; over time this moisture leads to the pre-mature degradation of the roof. The moisture appears warmer at night after a sunny day due to its greater thermal capacitance.

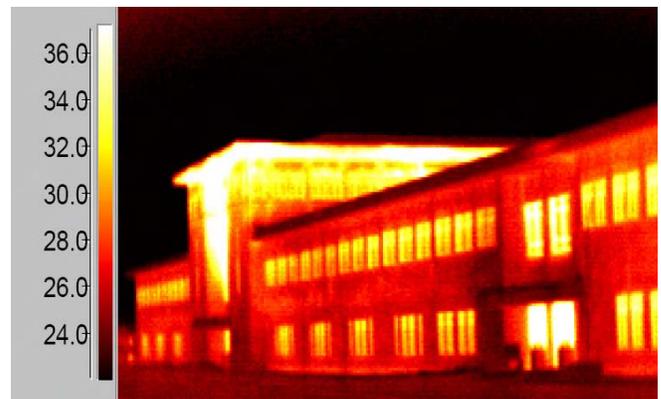
Image 11: During the commissioning of this building thermography revealed an extreme problem involving exfiltration through the soffit. Courtesy Phil McMullen.
