# The Use of Infrared Thermal Imaging for Home Weatherization

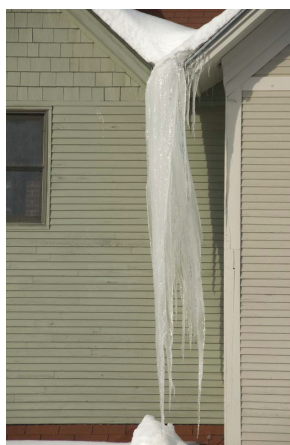
**Figure 1:** Icicles like this are a good indication of poorly performing insulation and/or ventilation.

Often the problems—as well as their causes and consequences—simply cannot be seen or may reveal themselves only after significant damage has been done. Homes in the “snow belt” (Fig. 1), for example, can end up with extensive ice dams resulting from roof/ceiling insulation and vent systems that do not perform adequately. Air leakage can also prove very problematic or time consuming to understand and reduce. One of the most troubling problems any WAP auditor faces is determining where insulation exists—and doesn’t—in an existing home. Success in correcting problems like these is often illusive because we cannot “see through walls” and the root causes are not obvious.

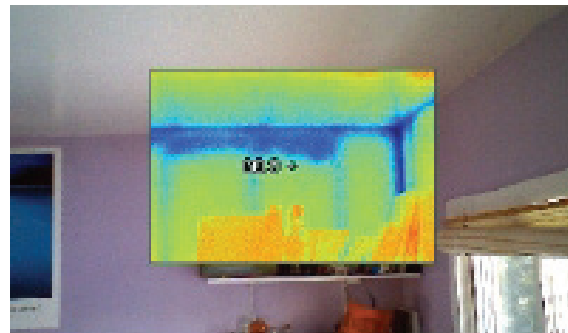
**Figure 4:** Properly installed cellulose is an excellent insulation. Unfortunately it is often poorly installed with missed areas and settling the most common quality problems.

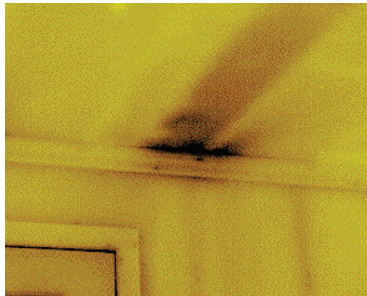
**Figure 5:** Batt insulation is susceptible to air infiltration. The fiberglass shown here does not stop airflow directly into the home or indirectly into the ceiling section.

As has been well documented in the WAP, excessive air leakage can account for up to half of the energy used to condition buildings. Of course adequate air exchange is essential for the occupants' health and safety, but most buildings have a far higher rate of air exchange than is necessary. The problems can be as straightforward as a failed door weather seal or as complex as an air pathway through a plumbing chase in an interior wall or ceiling plenum. The leakage pathway is often complex and, without infrared, extremely difficult to visualize (Fig. 5).
