# DRAWING ON THE PAST - DESIGNING THE FUTURE

FEBRUARY 1, 2017

# Vermont Integrated Architecture, P.C.

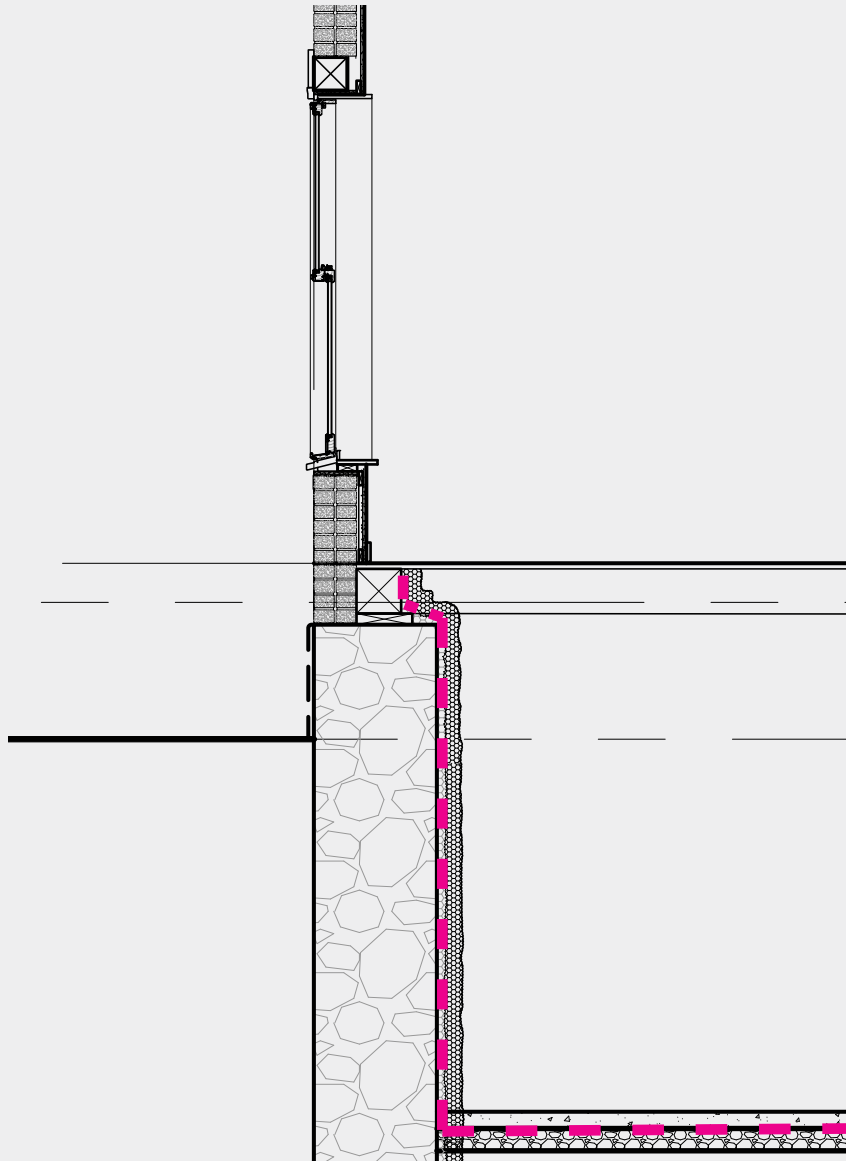
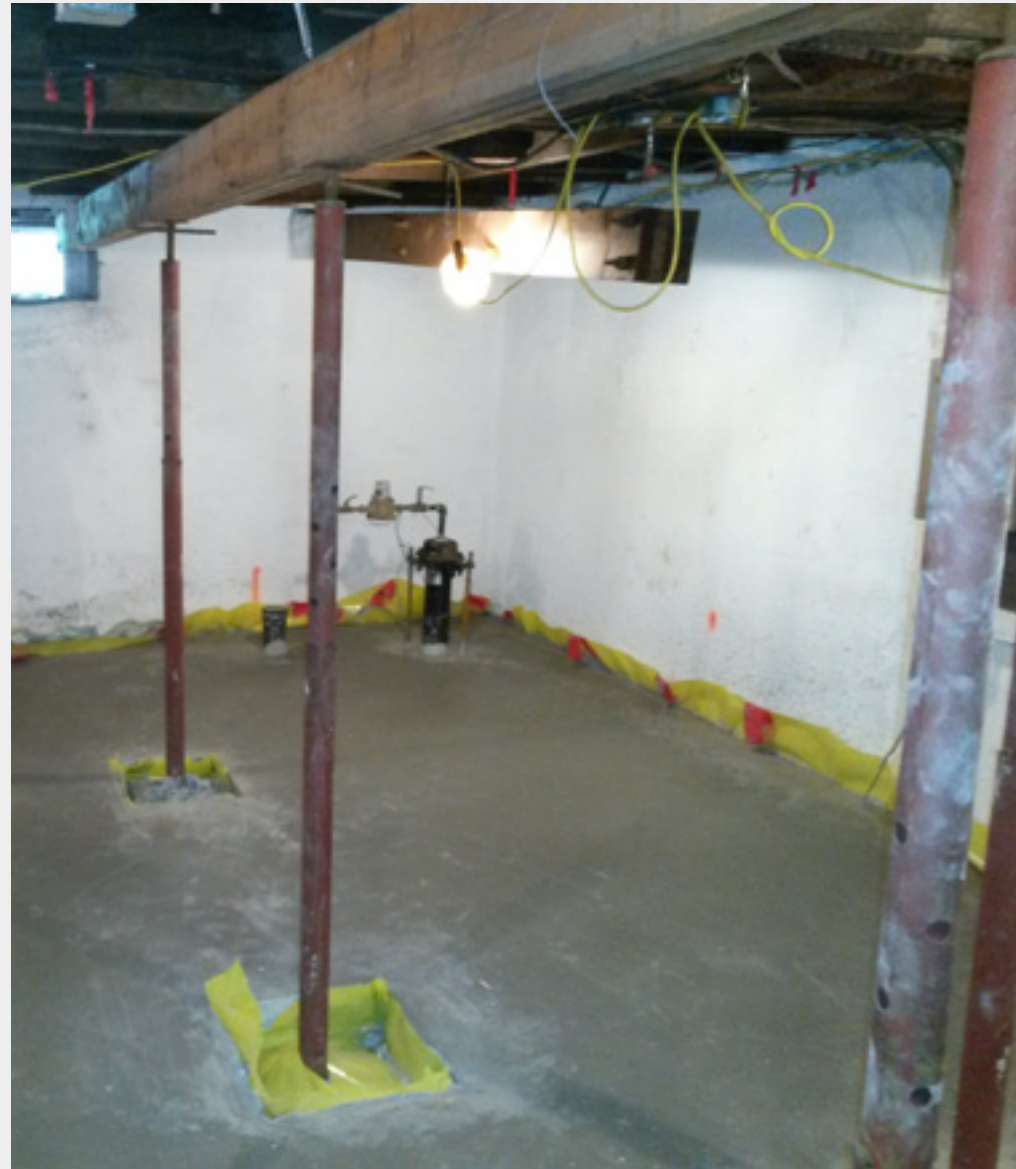
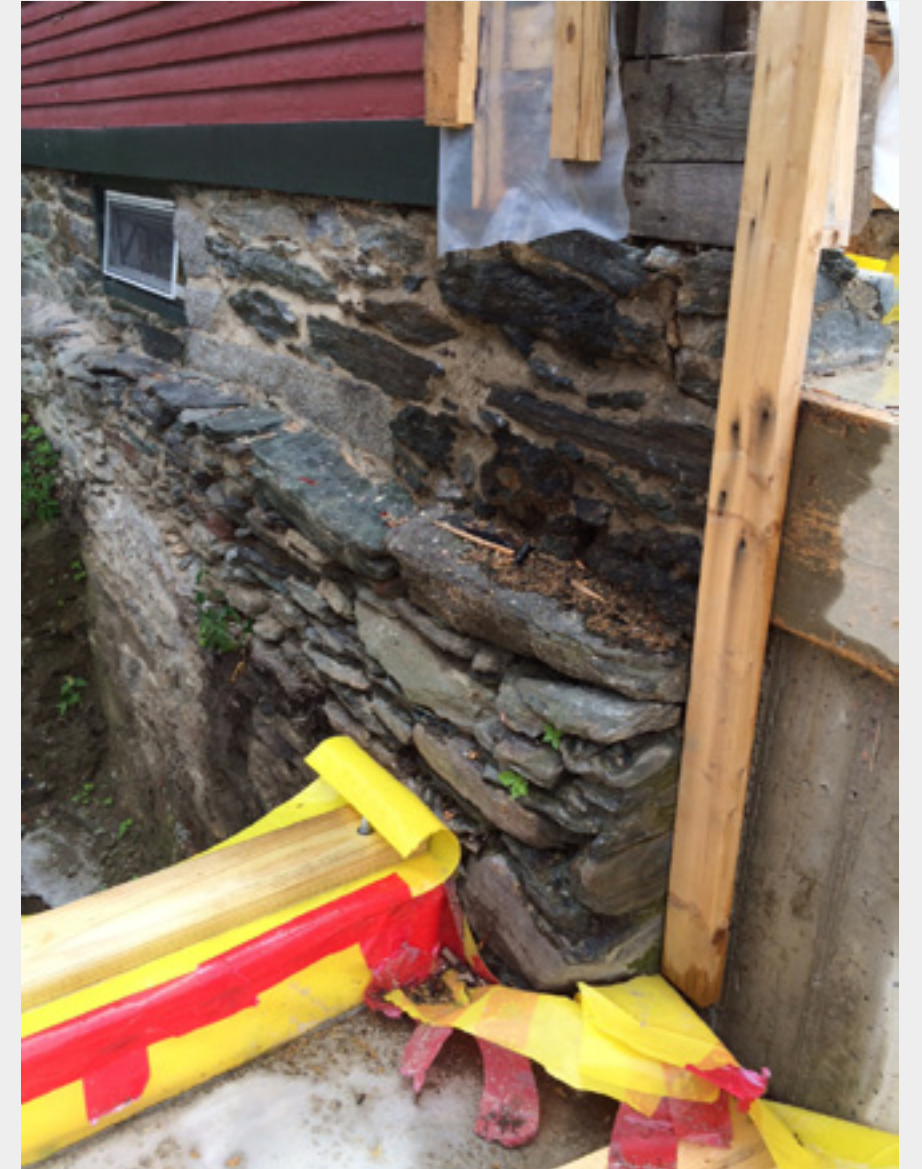
# FOUNDATION

## WATERBURY MUNICIPAL COMPLEX (JANES' HOUSE)

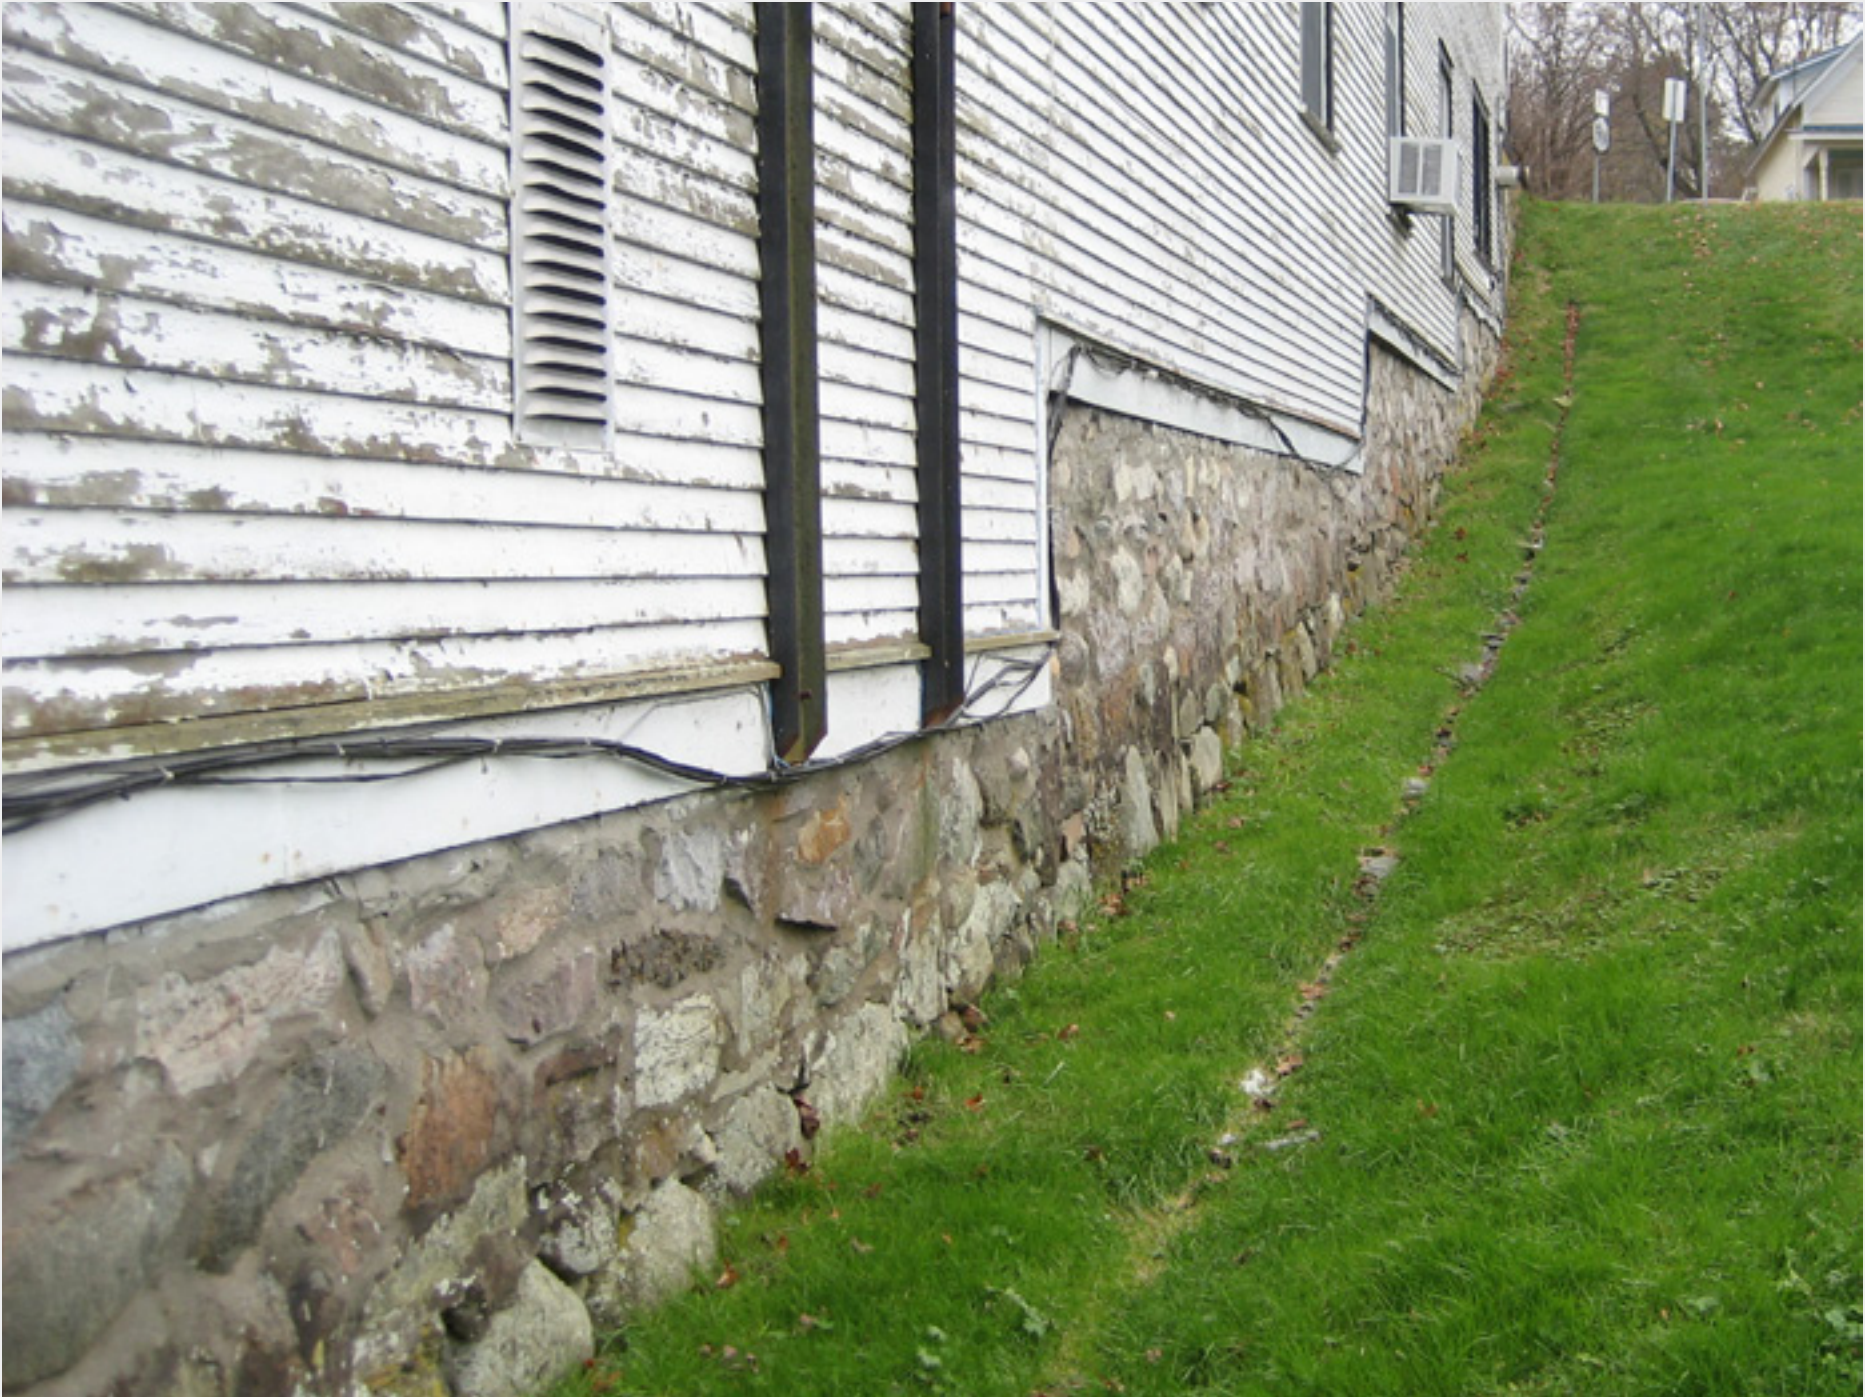
# FOUNDATION

## WESTPORT FOUNDATION

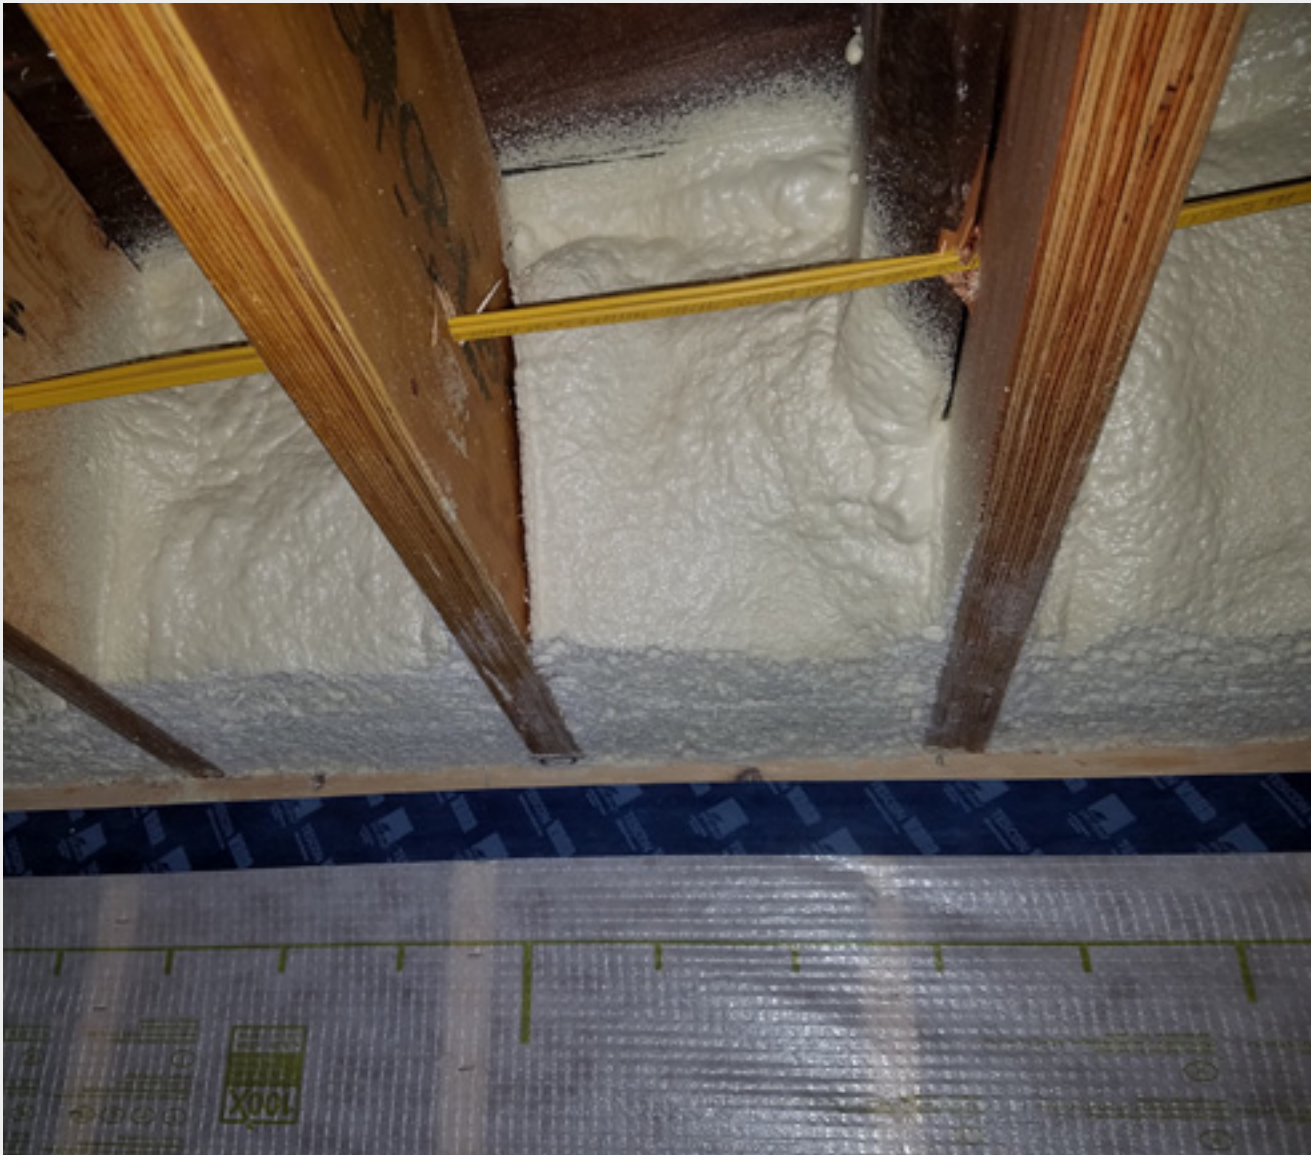
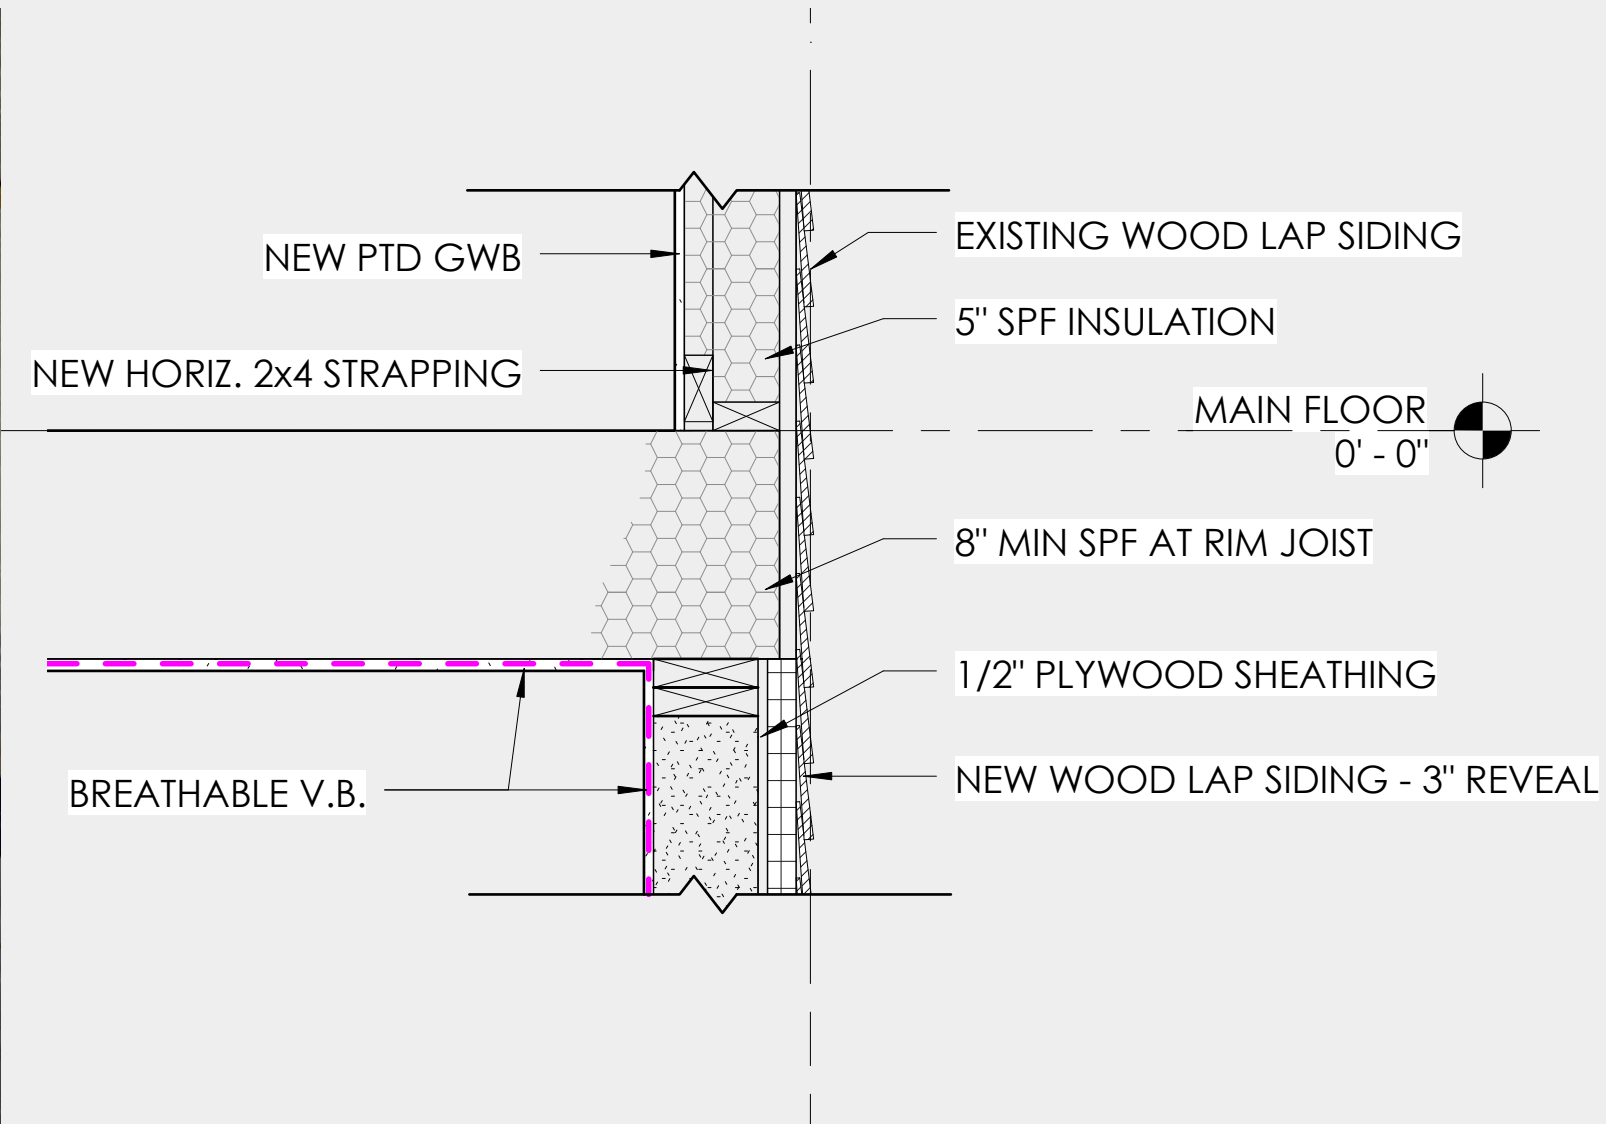
WALLS

CORNWALL - RIM JOIST

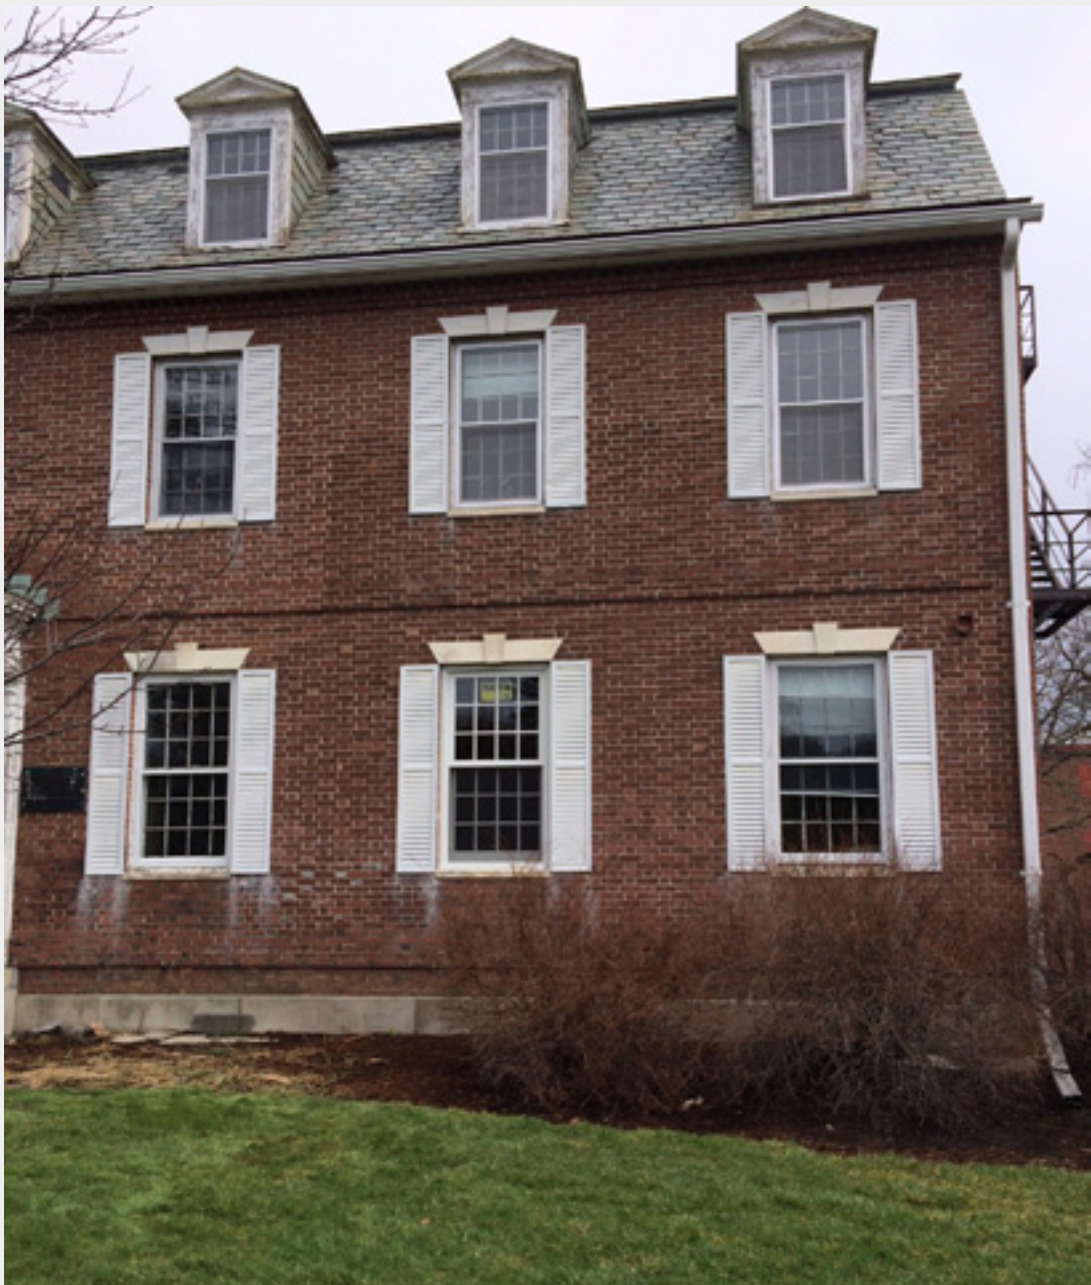
NOTE LOWER SASH WOULD HAVE A SCREEN FOR AT LEAST SOME OF THE YEAR

**1 Marvin Replacement Window**  
SCALE: 1" = 1' - 0"

PROS:

- Preserves function and overall aesthetics of original design intent.
- Matches proposed replacement windows on the rest of the building for unified composition.
- Good energy performance while being operable.
- Easy maintenance in the future.
- Each pane of glass reads separately like on the original window.
- Window could be preserved/recycled for another use

CONS:

- The artifact of the original window is removed.
- The check rail is slightly wider.
- Window pane sizes change slightly.
- Depth of muntin bar on the interior side of the glazing decreases.

== == == SIGNIFIES LOCATION OF STORM IN OPEN POSITION  
NOTE LOWER SASH WOULD HAVE A SCREEN FOR AT LEAST SOME OF THE YEAR

**2 OPERABLE ALLIED STORM WINDOW**  
SCALE: 1" = 1' - 0"

- The artifact of the original window is preserved in place.
- The window remains operable. This storm will be better looking than the one that is currently on the building.

- The most expensive option.
- The storm window creates a unified plane of glare that could disrupt the view of the preserved window.
- When the storm window is in the up position it creates two wide horizontal lines. When the storm is left open while the original sash is closed, the look is clunky.
- Operability is compromised because two sashes need to be opened and closed.

**3 SINGLE LITE ALLIED STORM WINDOW**  
SCALE: 1" = 1' - 0"

- The artifact of the original window is preserved in place.
- Simple lines of the storm panel only interrupt the depth of the originally designed assembly.

- The second most expensive option.
- The storm window creates a unified plane of glare that could disrupt the view of the preserved window.
- Potential for condensation between windows could lead to increased rot of the restored original sash
- Requires additional mechanical ventilation (extra cost).

**4 EXISTING WINDOW**  
SCALE: 1" = 1' - 0"

- Lovely window; beautifully proportioned and crafted.

- Contaminated with lead and asbestos.
- Does not keep out the weather:
  - Major source of air leakage.
  - Thermal performance of single pane glass no longer acceptable.
- Very expensive to rehabilitate.

Note: Rebuilding the window with 8-Glass has been deemed unacceptable during previous conversations.

PLEASE NOTE THAT THE DOOR AND "HOOD" WILL BE RESTORED PER THE ORIGINAL DRAWINGS.

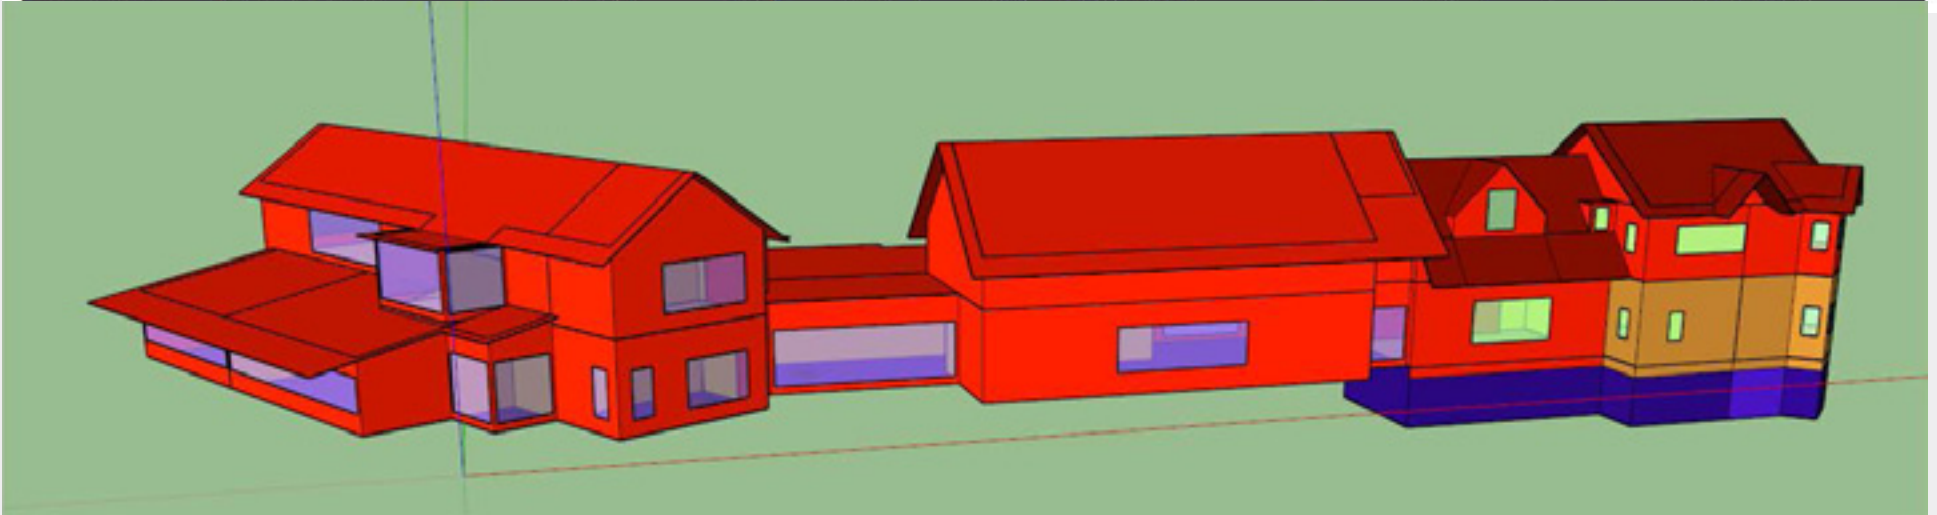
# ENERGY MODELING

Building Envelope (Construction Assemblies)										
Name	Description	Base Building U-Factor (Btu/h-ft <sup>2</sup> -F)	Base Building Envelope R-Value	Improved Envelope U-Factor (Btu/h-ft <sup>2</sup> -F)	Improved Building Envelope R-Value	Code Max U-Value	Gross Area (ft <sup>2</sup> )	Window Area (ft <sup>2</sup> )	Net Area (ft <sup>2</sup> )	Window To Wall Ratio
Old Underground Floor Construction	Existing Concrete Floor	F-Factor 0.73	N/A	F-Factor 0.73	N/A	F-Factor 0.73 (pre-existing construction)	1,821	-	1,821	N/A
Concrete Wall	Existing Concrete Wall with R-20 Added Insulation	U = 0.269	2	0.043	23.0	U = 0.269 (pre-existing construction)	261	43	218	17%
Existing Brick Wall	Existing Brick Wall, wood framing, air cavity, plaster	U = 0.24	N/A	0.240	4.2	U = 0.24 (pre-existing construction)	1,177	104	1,073	9%
Existing Ext Wall Construction	Second floor wall construction on original building - wood siding, wood framing - infilled with insulation	U = 0.26	N/A	0.043	23.4	U = 0.26 (pre-existing construction)	3,251	316	2,935	10%

Existing Roof	Existing Roof on original building - proposed addition of R-60 Insulation	U = 0.288	N/A	0.016	62.4	U = 0.288 (pre-existing construction)	2,333	-	2,333	N/A
Ext Wall Construction	Exterior wall for new building - proposed R-40 construction. Final wall details to be determined.	U = 0.049	R-20	0.023	43.3	U = 0.049	9,836	2,217	7,619	23%
Old Underground Wall Construction	Existing Concrete Wall with R-20 Added Insulation	C-Factor 0.048	N/A	C-Factor 1.14	N/A	C-Factor 0.048 (pre-existing construction)	1,278	-	1,278	N/A
Roof Construction	Roof Construction for New building - metal surface, proposed R-60 construction - final details not yet determined	U = 0.023	R-30	0.016	62.4	U = 0.032	9,012	-	9,012	N/A
Thick Concrete Wall	Existing Concrete Wall, 2' exterior stone with R-20 Added Insulation	U = 0.269		0.043	23.2	U = 0.269 (pre-existing construction)	88	-	88	N/A
Underground Floor Construction	Slab fully insulated with R-20 under slab	F-Factor - 0.480	N/A	F-Factor - 0.261	N/A	F-Factor - 0.480	7,947	-	7,947	N/A

ENERGY MODEL AND IMAGE PROVIDED BY SECOND LAW ENERGY MODELING

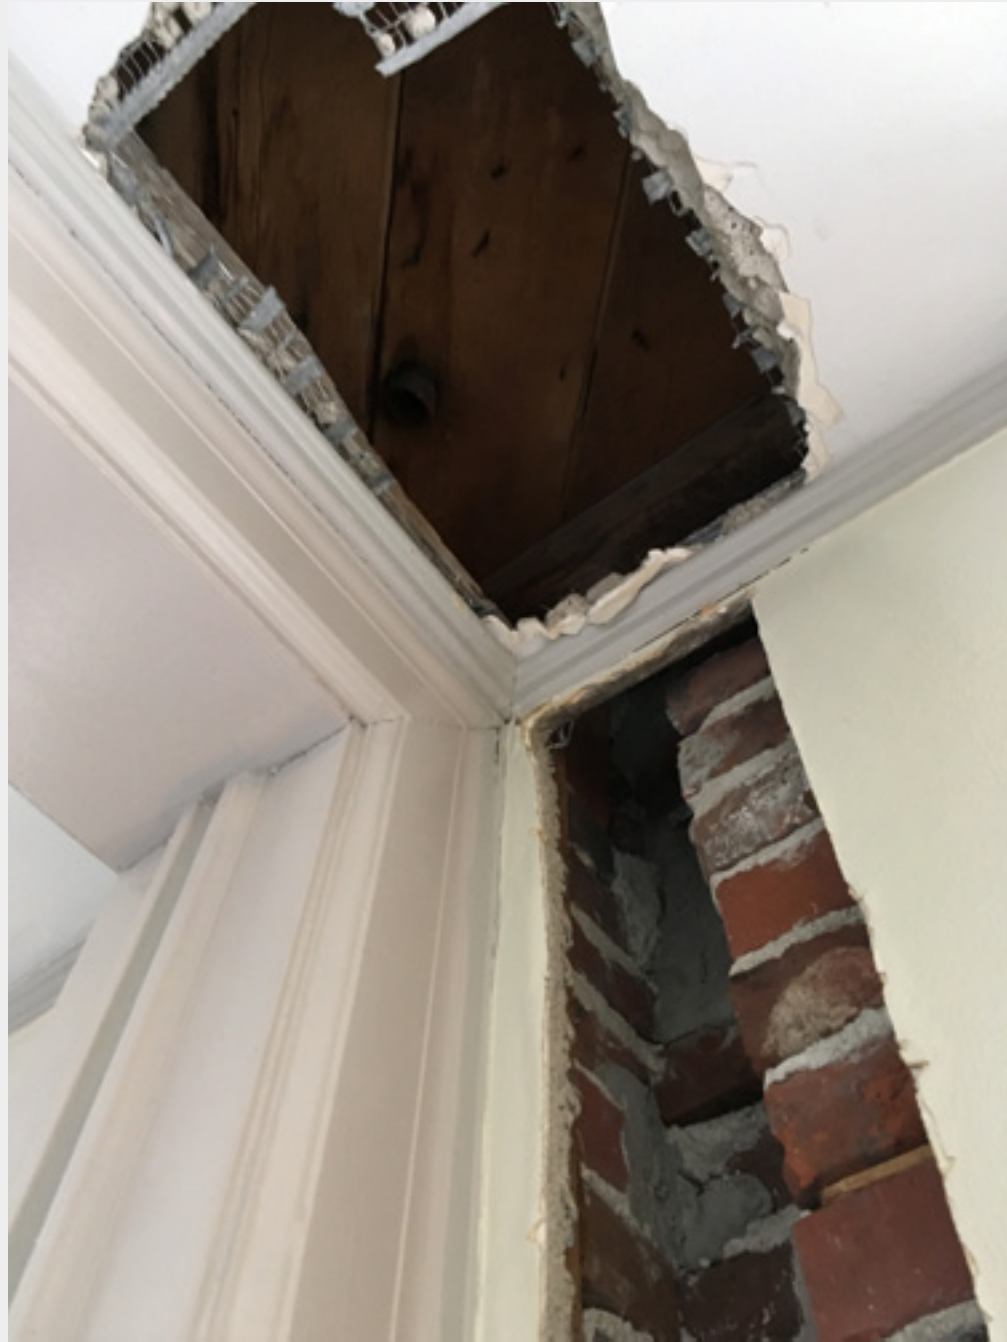
REMOVING OLD SYSTEMS BEFORE INTRODUCING NEW

Slade Hall Steam Heat Removed

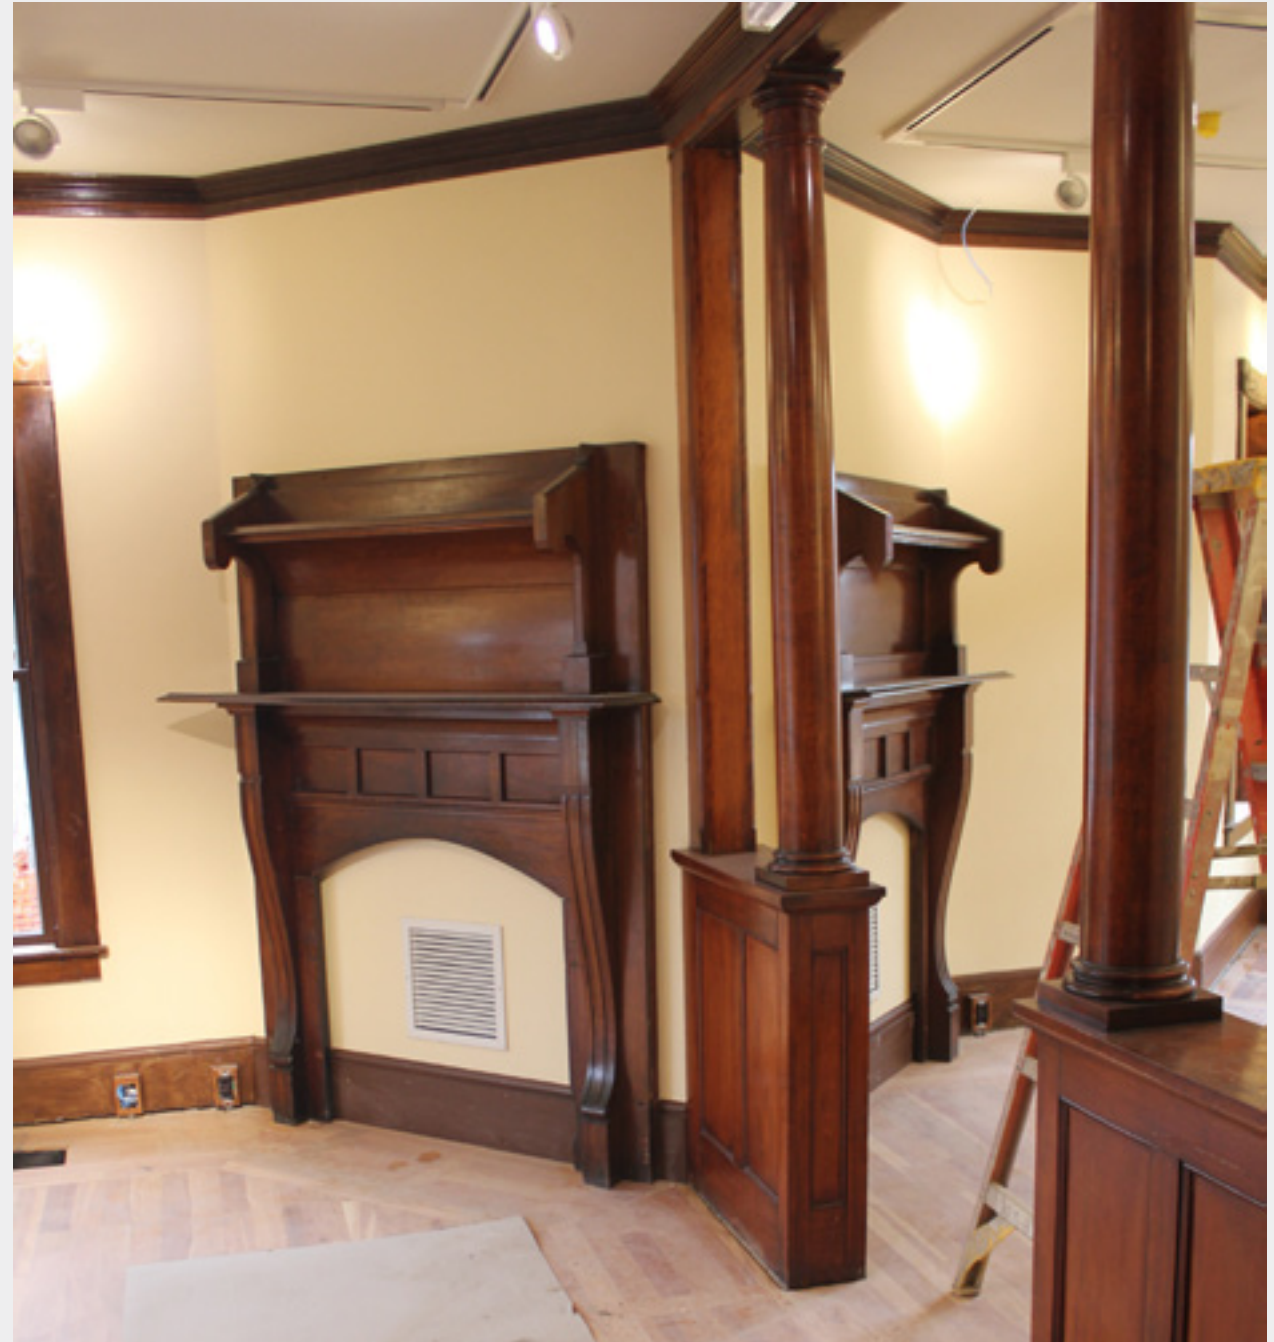
Waterbury-Janes' House New HVAC
